Aircraft Materials Technical Memorandum 405

**FIELD EVALUATION OF SIX PROTECTIVE COATINGS APPLIED TO T56  
TURBINE BLADES AFTER 500 HOURS OF ENGINE USE**

S.G. RUSSO

JUNE 1991

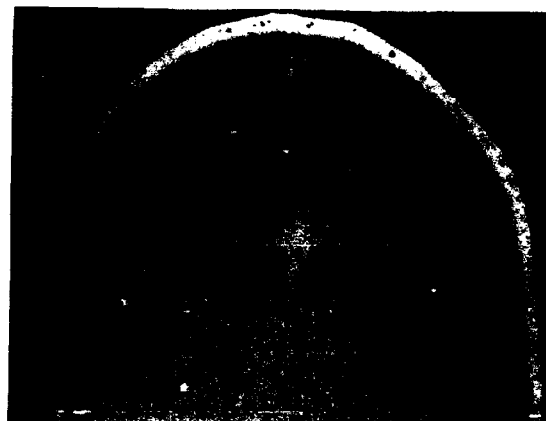
**Figure 7** Comparing the trailing edge micrographs of the (a) silicon-modified aluminide with the (b) platinum-modified aluminide. The latter is the more desirable coating since the silicide coating shows large variations in thickness.

Results for the silicon-modified aluminide coating indicated favourable results in combatting the effects of hot-corrosion with the formation of a  $\text{SiO}_2$  scale, in addition to the  $\text{Al}_2\text{O}_3$  and  $\text{Cr}_2\text{O}_3$  scales. The coating contained no evidence of cracking, which was highly unexpected since the ductile/brittle transition temperature (DBTT) of this coating was much higher than the others <sup>(7)</sup>. Application of the aluminium and silicon slurry was carried out manually and is thus dependent on the skill of the operator to achieve a coating with consistent thickness. Figure 7 illustrates areas of local thinning and thickening in the coating brought about by the blades complex shape.
